# Village of Bellows Falls/ Town of Rockingham

Town Hall, Public Library, Public Safety Building

## Accessibility Evaluation

March 18, 2016

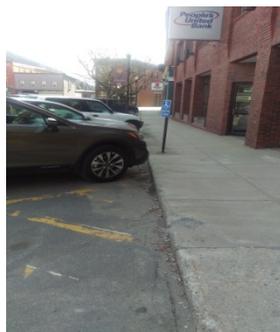
The present signed space, nearest the accessible Town Hall entrance, includes a triangular access aisle 12’ wide at the base, and 14’ deep perpendicular to the sidewalk. An access aisle must be a minimum of 60” wide along the full depth of the accessible parking space (for a passenger car) or 96” wide for a “van accessible” space. When accessible parking is provided, one accessible space in six (but at least one space) must be van accessible.

A compliant access aisle serving this designated accessible space will intrude into the mouth of the alley, which is an active, albeit limited, path of vehicular traffic. An access aisle may not overlap a path of vehicular traffic.

In this instance, the necessary access aisle at the designated accessible angle parking space can be created by designating the adjacent parking space the accessible space, and striping the present space as the access aisle. In a designated van-accessible space, the access aisle should be on the passenger side.

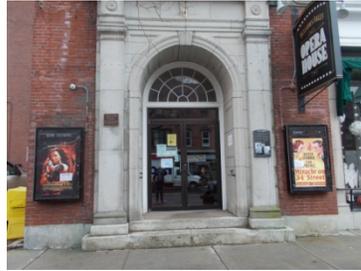
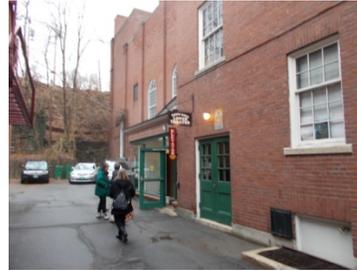
The apparent main entrance to the building includes irregular granite steps and is not accessible. When the main entrance is not the accessible entrance, a sign must be posted directing a user to the nearest accessible entrance. While a paper sign at this entrance indicates the route to the accessible entrance, a permanent sign is required.

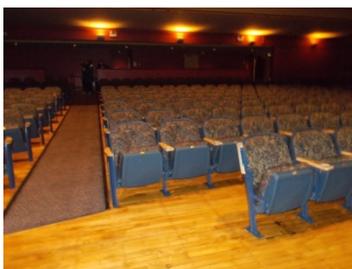
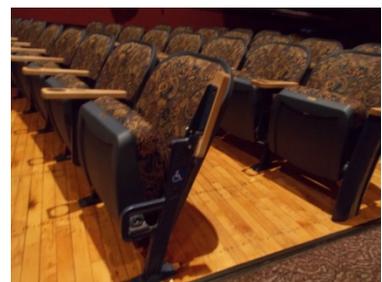
Two front row spaces, one at each end of the center section, appear to be wheelchair specific: that is, each end chair in the row is missing. The floor here is not functionally level (sloping less than 1:48 in both directions), and if leveled by low wedged platforms here a trip hazard may be created. Similarly, the companion seats adjoining these present, presumptive wheelchair spaces can't be "shoulder aligned" unless the wheelchairs are so close to the seats behind as to render those seats unusable. Creating wheelchair seating at the very front, on the level "orchestra" floor, disadvantages the viewer by limiting the line of sight.

To achieve the required 36"x60" footprint for a wheelchair space elsewhere in the raked seating array could involve the displacement of at least 4 seats for each wheelchair space. It can be argued that the loss of so many seats could have a significant economic impact on theater operations. Still, seats in these designated spaces can be engineered for quick removal or replacement as needed. Staff training, then becomes key for identifying and accommodating any imminent, yet temporary need.

Similarly, a level platform for such seats would need to extend into the aisle to facilitate maneuvering into the created wheelchair space. The resulting step at the downsloping edge of this platform would be a potential trip hazard, and would unacceptably limit wheelchair accessible route to the elevator serving the stage.

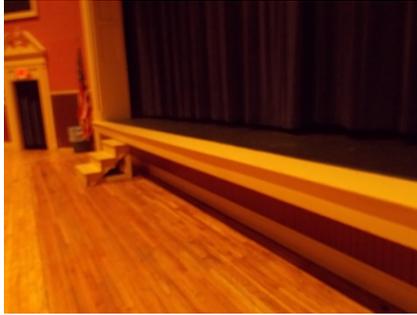
Presenters may access the stage by either of two sets of portable steps directly in front of the stage, or by a LULA vertical lift to the right of the stage. The doorway leading to the LULA allows a clear opening of 31": however, 32" is the minimum required clear opening in doorways. Clear opening is the narrowest distance measured from the door jamb on the latch side to the face of the door on the hinge side, when open 90°. In this case, additional clearance can be obtained by replacing the standard butt hinge with an offset hinge, which effectively increases the clear opening by the thickness of the door.

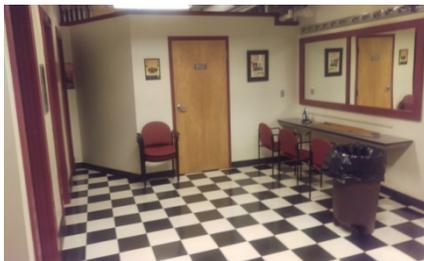
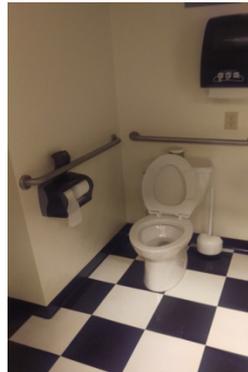
Three dressing rooms are not accessible, due to original, narrow (27 ½" wide) doors, and coat hooks/hangers mounted 68" above the floor. Widening at least one of the three dressing room doors, and lowering the hooks, would be considered readily achievable: that is, achievable without an undue financial or administrative burden.

The unisex, single-user restroom includes inaccessible features as well: the paper towel dispenser is set at 52" aff and should be lowered. The grab bar is set at 37 ½" to the top of the bar: the standard defines the measure to the top of the bar, not the center. The grab bar on the adjacent wall is only 36" long, while 42" is required by the standard.

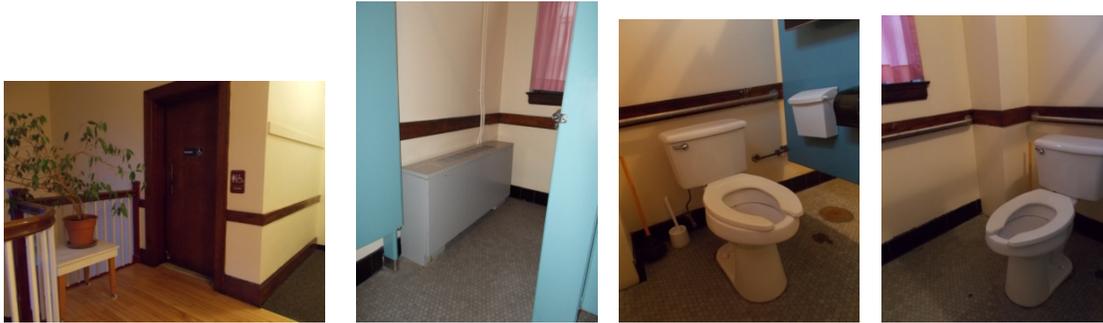
Clear opening at the toilet compartment is compromised by the presence of a heating radiator restricting the required path of travel. The partition could easily be removed, since the room is treated as a single-user space. Similarly, the partition could be replaced with a half wall, placed closer to the toilet to support a grab bar at an appropriate height and distance from the toilet. A halfwall, if built, must support the 250lb pull required of grab bar anchors.

The grab bar presently installed on the outer wall is too far from the toilet and is useless as a stabilizing or transfer aid. A chase built into the corner further complicates the design of an accessible layout.

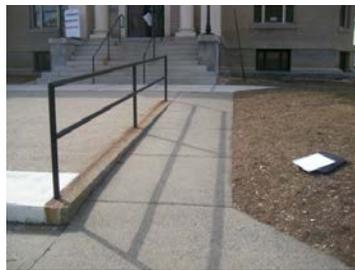
The earlier principal route to the main entrance included a wide cement apron, sloping to a single step at the Main Street sidewalk. A stepless walk was created next to it, and a single railing was installed to limit the trip hazard created by these changing levels.

This walk, with a slope greater than 1:20, is technically a ramp and requires bilateral handrails. The handrails do not need edge protection.

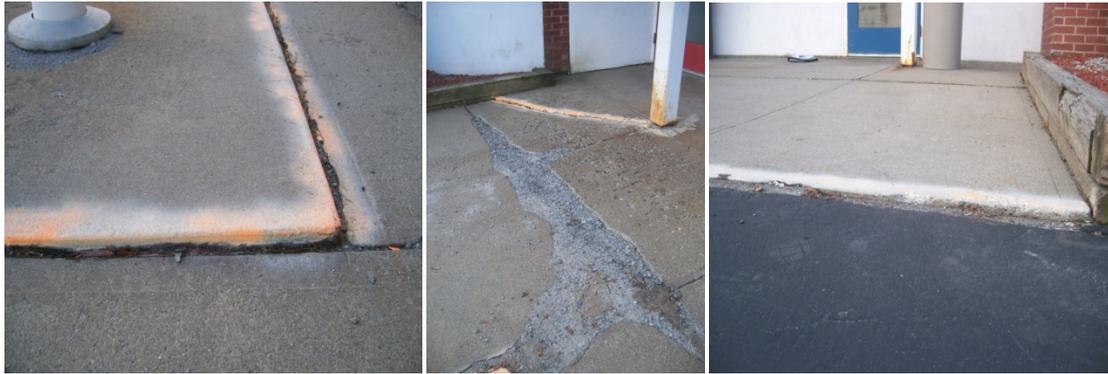
The threshold of the police department front door is too high, and constitutes a trip hazard. Thresholds in existing buildings may be  $\frac{3}{4}$ " high, but may not present a vertical change of level more than  $\frac{1}{4}$ ". Change of level above  $\frac{1}{4}$ " must be beveled with a slope no greater than 1:2

- refresh striping at the accessible parking space and access aisle
- repair vertically dislocated and crumbling cement surfaces at entrance
- wedge the transition at the police department threshold to eliminate trip hazard
- reverse police waiting room restroom door swing to facilitate egress
- adjust restroom accessories to current standard: grab bar, mirror height, shield lavatory plumbing
- relocate restroom signage to adjacent wall at correct height
- provide lower service counter, or alternate, accessible work surface
