# Village of Bellows Falls/ Town of Rockingham

Town Hall, Public Library, Public Safety Building

## Accessibility Evaluation

March 18, 2016

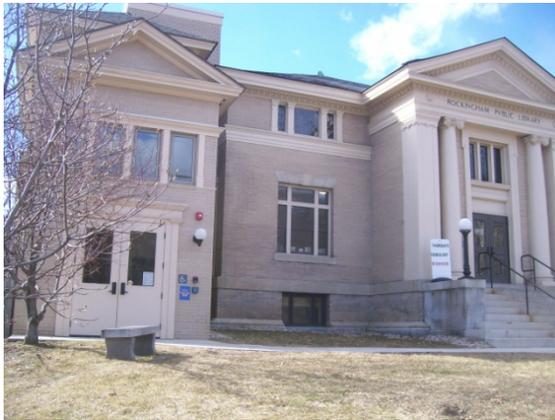
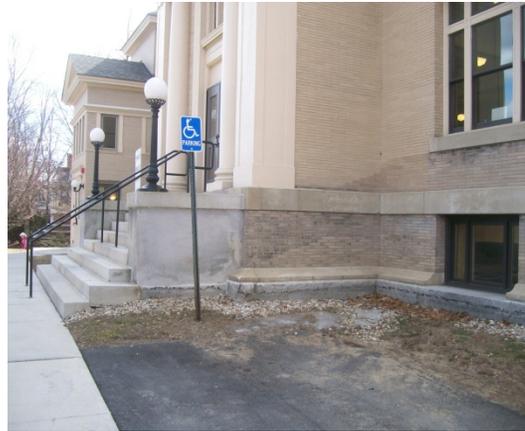
## Rockingham Public Library

Extensive alterations have recently been completed at the Rockingham Public Library: one of only four Carnegie Libraries in Vermont. Inaccessibility was a principal driver for this project. The Library now includes accessible routes to four levels, with accessible restrooms located on two levels.

While the project was well thought out, planned, and carefully executed to insure accessibility, a few issues remain and merit observation.
